Millions of Dirhams in damage was caused by overlooking the penetration of the Air and Vapour barrier in a flawed value engineering study for a building wall assembly.

A Case Study- Unintended Consequences of Cost Cutting in Value Engineering

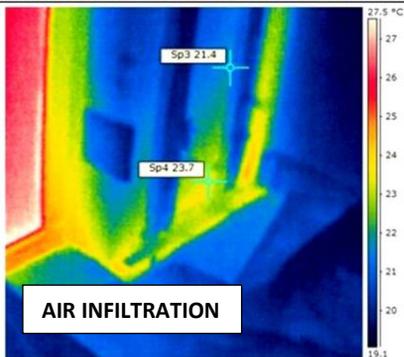
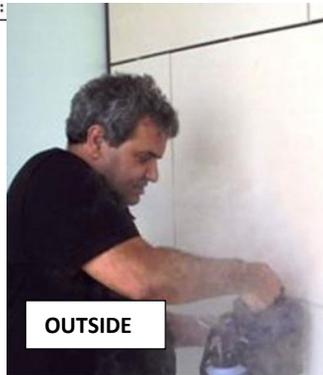
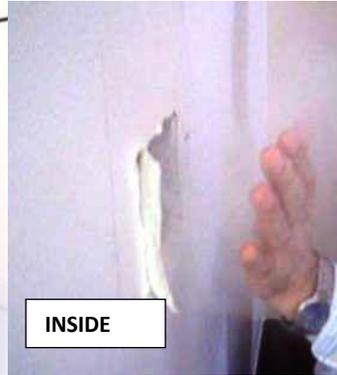
INFRARED IMAGE OF EXTERIOR WALL COLUMN ENCLOSURE:

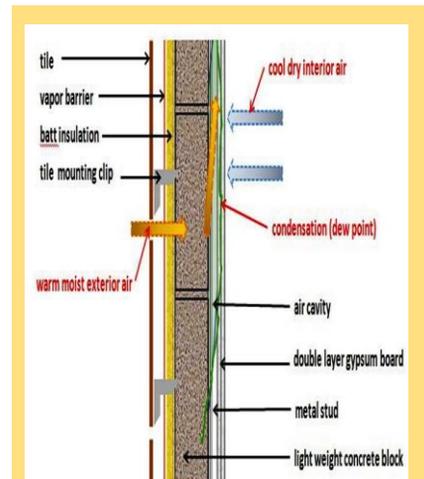
This diagram illustrates how the multiple penetrations became a conduit for warm, moist water laden air flowing through the porous block wall mixed with cool, dry interior air. When the moist outside air meets the cooled, drier air-conditioned air the water vapor in the exterior air condenses into liquid water. The interior gypsum board walls had a constantly replenished source of moisture, which allowed mold spores to settle and feed on the gypsum board paper backing. The mold damage was wide spread and indiscriminate as the entire façade provided no barrier to exterior water vapour and air penetration.
